# Glitching Firmware Readout Protection in an EV Charger and Instrument Cluster

## Case Studies on GD32 and RH850 MCUs

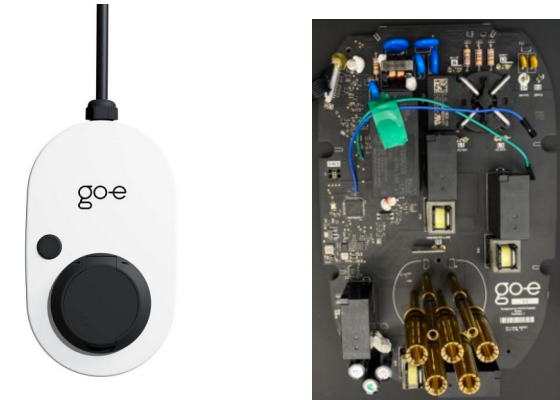
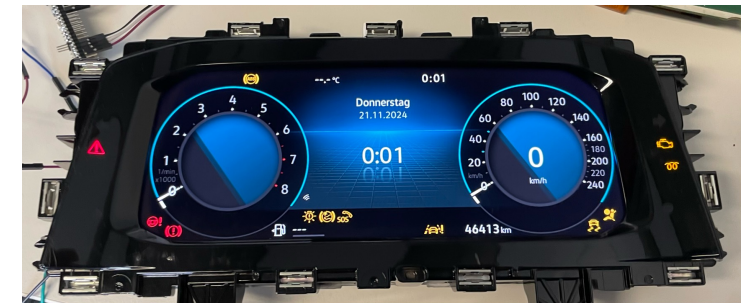
- Attacker capabilities:
  - Physical possession or prolonged access to the target
  - Access to boot-mode signals, UART, reset, and a supply node
  - No valid unlock credential
- GD32
  - GD32F303RCT6 used in the go-e Charger
  - Experiments on a development board
- RH850
  - R7F701401 (RH850/D1L) in a VW instrument cluster
  - Experiments directly on the production cluster
